“THREE CRABS” AREA ASSESSMENT

An assessment of water quality, flooding, fish and wildlife habitat issues and recommended actions for the “Three Crabs” area between the Dungeness River, and Cassalery Creek, Washington

“Dungeness Comprehensive Water Quality Study”
Washington State Department of Ecology grant # G0600181

Prepared by the **Clallam Conservation District**

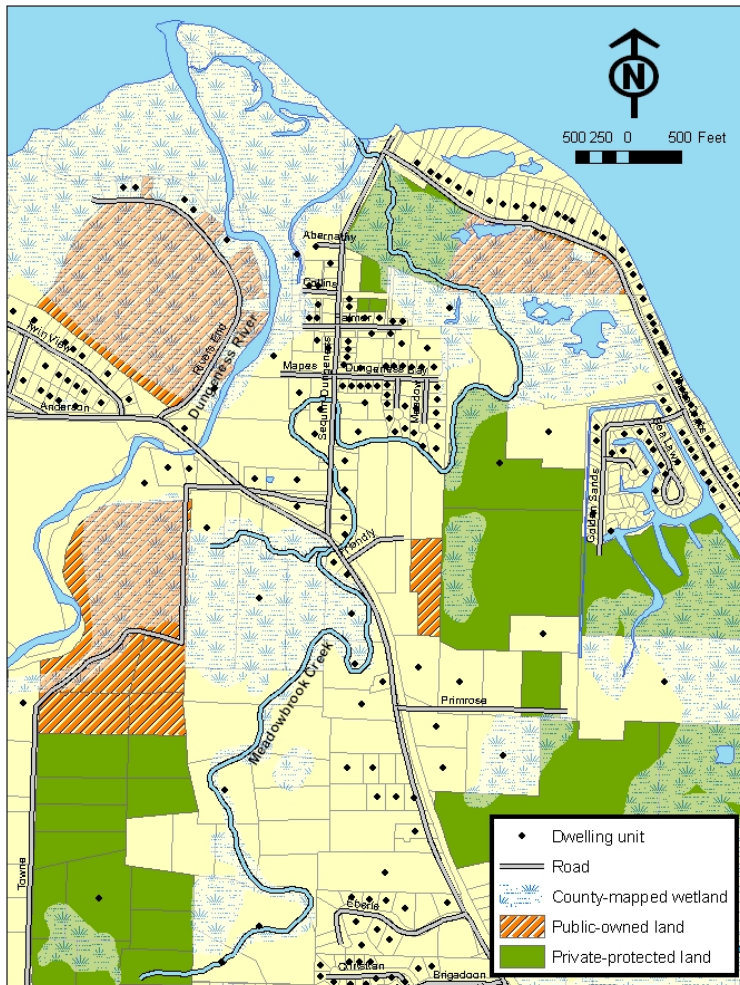
Figure 13 - Meadowbrook Creek sub-basin general ownership and land cover. (Source: 2007 Clallam County GIS data, with updated 2008 information for Rivers End Road)

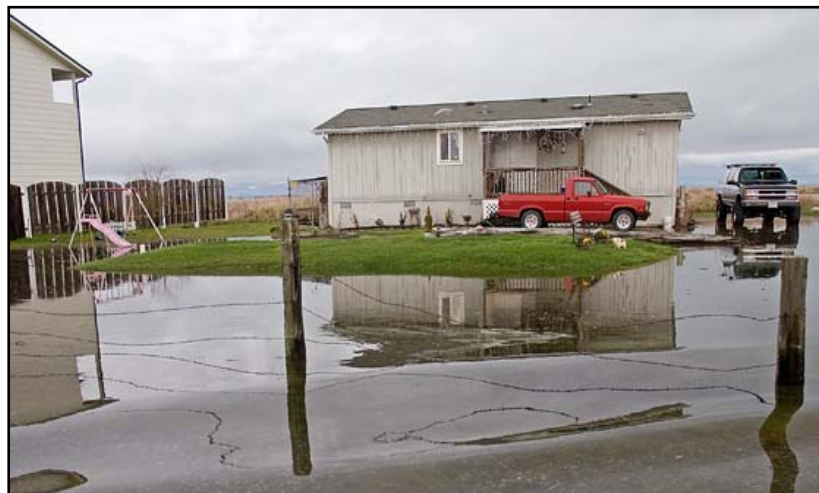
Figure 15 - Flooded septic drainfield along Three Crabs Road.

Reports of failing septic systems and “septics of concern” are not surprising, given the environmental challenges in this area. According to the USDA Soil Conservation Service *Soil Survey of Clallam County Area, Washington*, the predominant soil type in the Meadowbrook Creek area is Lummi silt loam, a hydrologic group D soil (hydric). It has a seasonal high water table from October to June that is within 6-24 inches of the surface. This soil has a severe limitation for on-site

septic systems due to wetness and is not suited for conventional septic drainfield systems.

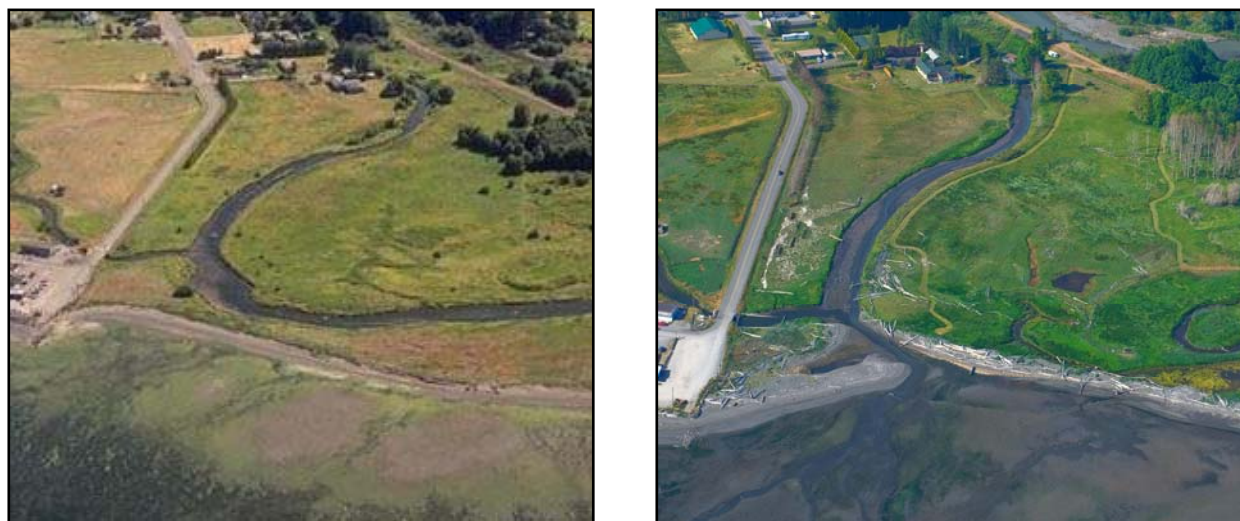
Figure 16 - End of Sequim-Dungeness Way, Meadowbrook Slough and mouth of Meadowbrook Creek in 1994 (left) and 2006 (DOE shoreline aerial photos).

Portions of the streambed where the creek breaches the beach dune, consists of a dense mat of fibrous material that appears to be compressed, partially decomposed organic matter mixed with silt and some gravel. This material appears to be very resistant to erosion. The stream has been moving westward from the original breach location as the drift cell in front of the Three Crabs Restaurant grows and migrates westward.

The point where SDW terminates at the beach is well armored with rock rip-rap. This is the location of the former pier, which originated some 1,130 feet inland where SDW makes a slight turn. Approximately 100 feet from this point is a power pole where power lines to the Dungeness Spit lighthouse go from overhead to buried/ submersed. The shoreline armoring also protects the western parking lot for the Three Crabs Restaurant. Clallam County Public Works maintains a right-of-way there and also maintains the shoreline armoring. The armoring of this point affects the deposition and erosion of marine longshore drift, exacerbating scour and beach erosion immediately west of this point.

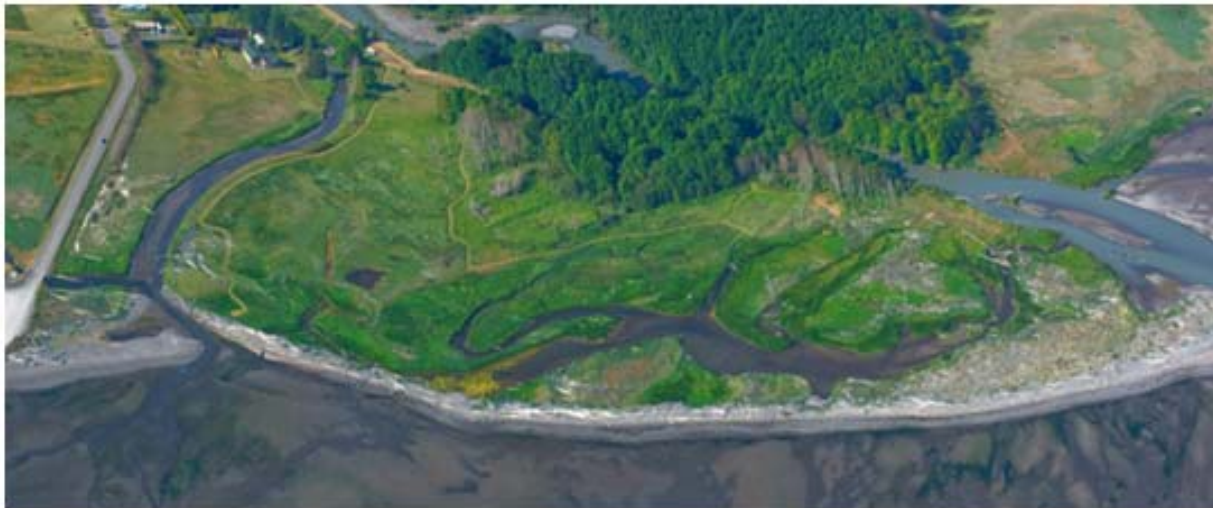
Figure 18 - Meadowbrook Creek outlet, slough, estuary, and Dungeness River (DOE photos, 2006)

Estuarine function is limited, due to the sand spit breach at the current stream mouth and by the bridge at SDW. Historically, the mouth of Meadowbrook Creek drained into Dungeness Bay either as a tributary to the Dungeness River, or directly into the bay much farther downstream, near the mouth of the river. The location of the Meadowbrook Creek mouth has moved around as the longshore drift of marine sediment in the bay continually shifts in an east to west direction (Collins, 2005). As recently as the latter part of the 19th century, the shoreline in the area of the present-day mouth of the stream was approximately 1,000 feet farther inland than it is today. A substantial estuary, including lagoon and salt marsh existed in this area at that time (Collins, 2005). Today, a significant beach berm forms the shoreline and separates the former estuary from the bay. This beach berm is the highest elevation in the area and has been built up with houses and the Three Crabs Restaurant.

As was discussed under the Flooding section, the sand spit that protruded in a northwesterly direction immediately to the west of this point eroded in the winter of 1998-99, cutting into the Meadowbrook Creek channel. This effectively shortened the stream length by over 1,500 feet, making it much more vulnerable to high-tide influences. Now, stream access by juvenile Chinook salmon seeking quiet, estuarine backwater areas is more difficult than under pre-sand spit breach conditions.

In addition, the loss of Dungeness River flood waters that historically utilized Meadowbrook Creek as a flood release channel has also deprived the Meadowbrook Creek delta of sediment. Prior to construction of the Army Corps of Engineers dike, during high water events, flood waters from the Dungeness River spilled into Meadowbrook Creek, depositing sediment and increasing stream energy in the lower reach. Therefore, although the delta area at the mouths of Meadowbrook Creek and the Dungeness River are relatively young and very dynamic, it is very likely that the loss of Dungeness River flood flows and sediment are contributing factors to the recent sand spit breach (Haring, 1999, Collins, 2005).

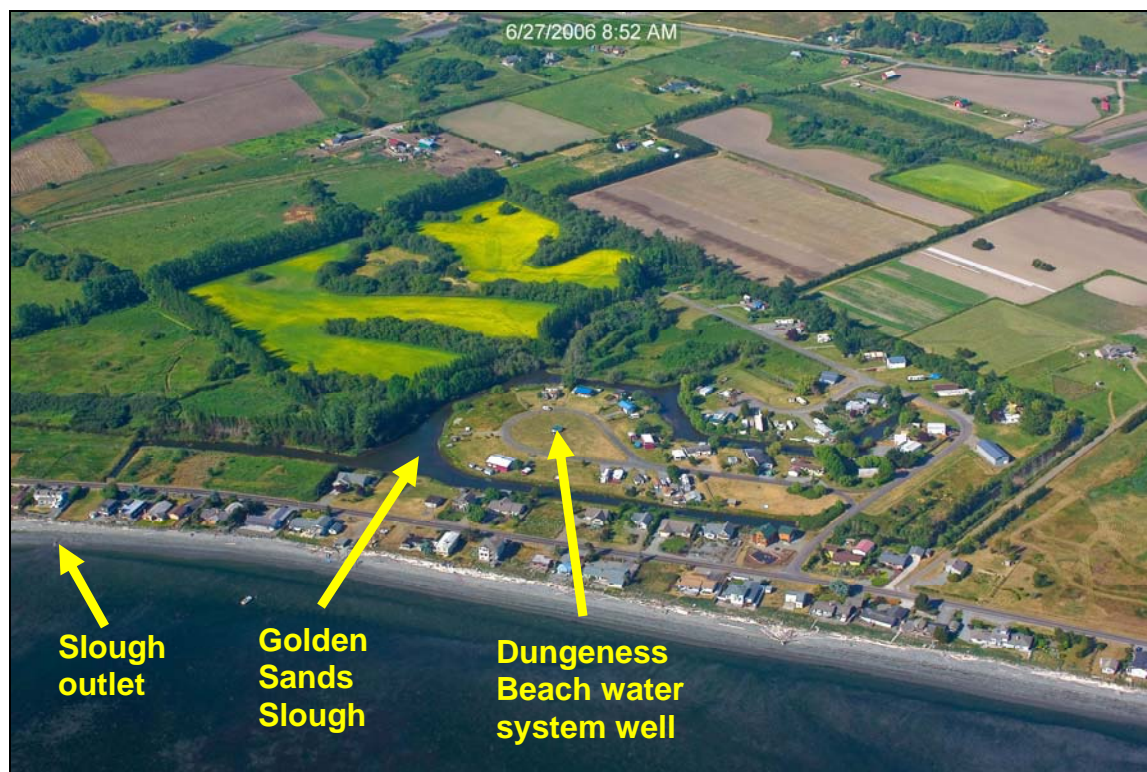
Figure 19 - 2006 DOE oblique aerial photograph

A series of canals were excavated into wetlands south of Three Crabs Road as part of a recreational component of the original Golden Sands development. This waterway (referred to as the “Golden Sands Slough”) is directly connected to Dungeness Bay through an approximately 250-foot long concrete flume under Three Crabs Road. These waterways were presumably constructed to provide boating access to Dungeness Bay. However, the developers abandoned the project (allegedly leaving the area with the investment money) and the canals were never completed (CWD Bacterial / Nutrient / Flow Effectiveness Monitoring QAPP, September, 2005).

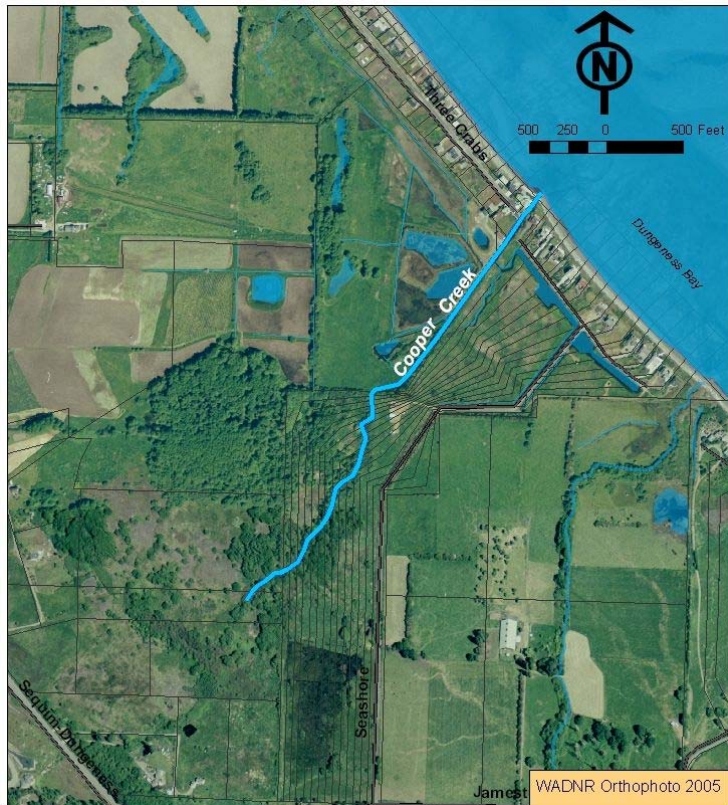
Figure 20 – Cooper Creek and vicinity

Cooper Creek is a small, low-gradient stream, roughly one mile in length with a watershed area of approximately 340 acres. It empties into Dungeness Bay through a tide gate between the terminus of Three Crabs Road and West Seashore Lane, approximately two miles east of the mouth of the Dungeness River and 1,500 feet west of the mouth of Cassalery Creek. Cooper Creek originates from low elevation, palustrine wetlands and agricultural land near the base of Kirner Ridge, north of Sequim Dungeness Way.

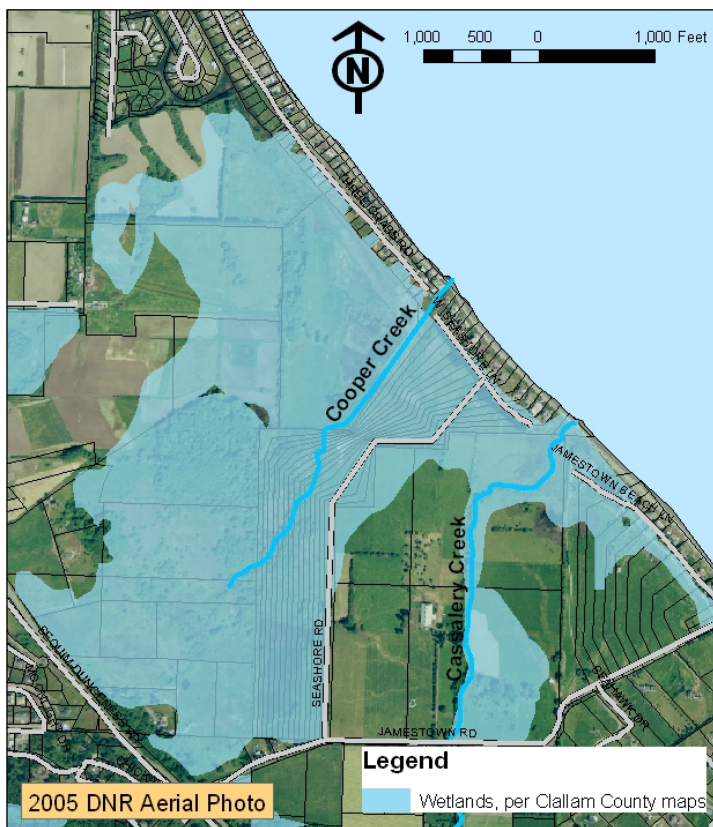
Figure 22 - County-mapped wetlands in the Cooper Creek Subbasin

Roughly 70 percent of the 340-acre Cooper Creek sub-basin is mapped as regulated wetlands on the Clallam County Critical Areas maps. Regulated wetlands are subject to protective buffers ranging from 25 to 200 feet, depending on the size and quality of the wetland and intensity of the proposed development. In addition to buffers, there are restrictions on most clearing and grading activities within 200 feet of the delineated edge of any regulated wetland. Other regulated critical areas affecting development within the Cooper Creek watershed include geologically sensitive (*Seismic Hazard*) Areas, *100 year floodplain*, and *Critical Aquifer Recharge Areas*.

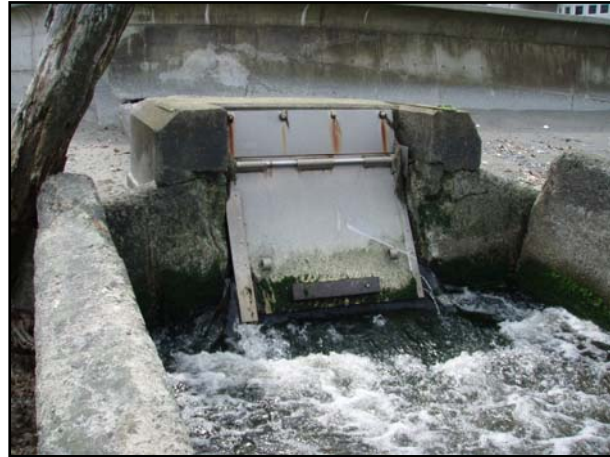
Figure 24 - tide gate at mouth of Cooper Creek (existing configuration)

Past problems with tide gate function have been attributed to clogging of the culvert with woody debris from upstream and kelp and gravel from the beach side. During heavy rain events in recent years, freshwater has backed up behind the clogged culvert and tide gate, flooding adjacent land upstream. The box culvert at the mouth is approximately 4 feet wide by 3½ feet tall with a “baffle” several inches off the bottom that tends to catch debris, contributing to clogging problems. No structures have been flooded during these events, but there have been reports of localized erosion and damage to landscaping.

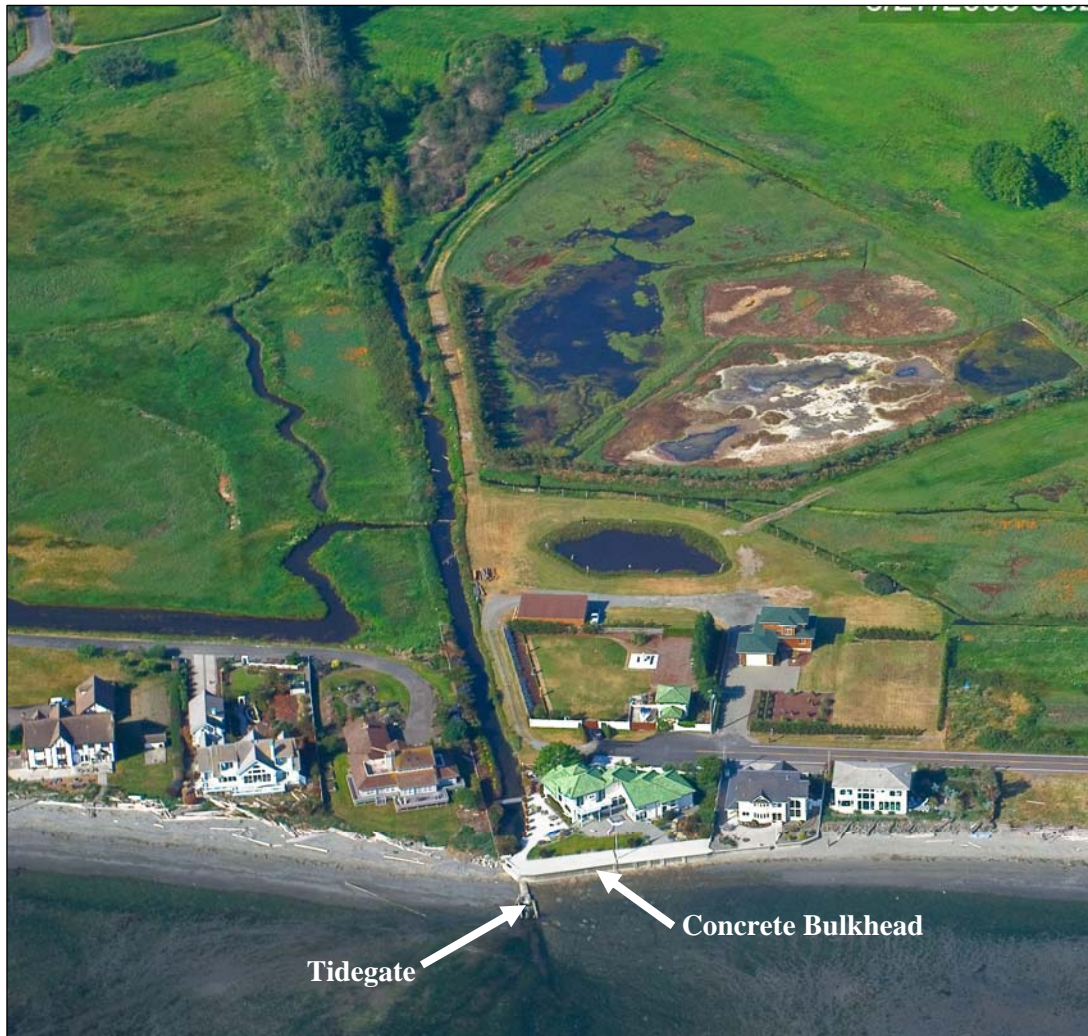
Figure 25 - Mouth of Cooper Creek (2006 DOE oblique)

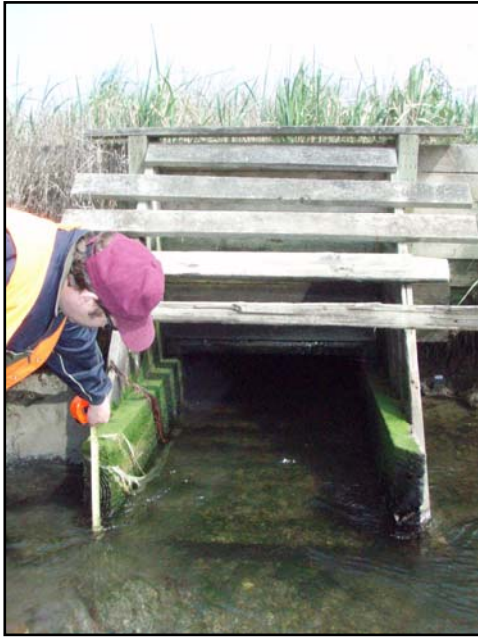
Figure 28 -Cassalery Creek culvert inlet (2007)

Seasonal flooding occurs at the mouth of Cassalery Creek when the culvert plugs with seaweed, wood, sand, gravel, and other debris. Debris must be manually removed when this happens; otherwise, impounded water from the stream floods neighboring properties, posing a hazard to septic drainfields, landscaping, roads, and other infrastructure. The approximately 100-foot long, by 2-foot, by 4-foot culvert at the mouth of Cassalery Creek has a wooden trash rack on the upstream end. It has been rebuilt at least twice over the past 80 years. When it was last rebuilt in 1986, it was constructed adjacent to the west side of the old culvert. This required the stream channel to make a slight curve at the inlet to the culvert, thus causing headloss and hampering the capacity to flush debris and sediment out of the culvert (NHC, 2007). According to the 1999 LFA, the mouth of Cassalery Creek likely formed a wetland pond/marsh on the upstream side of the beach berm prior to installation of the existing culvert.

Extreme high tides in winter can also result in salt water intrusion up the stream channel when the culvert is not plugged with debris. This contributes to localized flooding in the pasture immediately upstream and to the west of the culvert. The plant community in this area is indicative of salt water intrusion, consisting of a mix of pasture species and salt-tolerant herbaceous species, interspersed with large areas of bare ground.

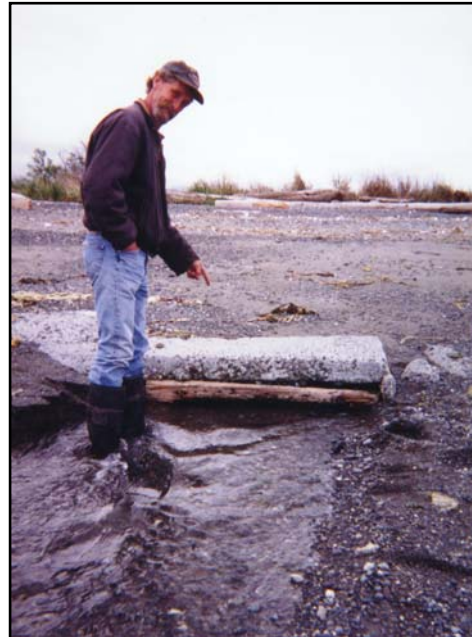
Figure 29 -Cassalery Creek culvert outlet (2000)

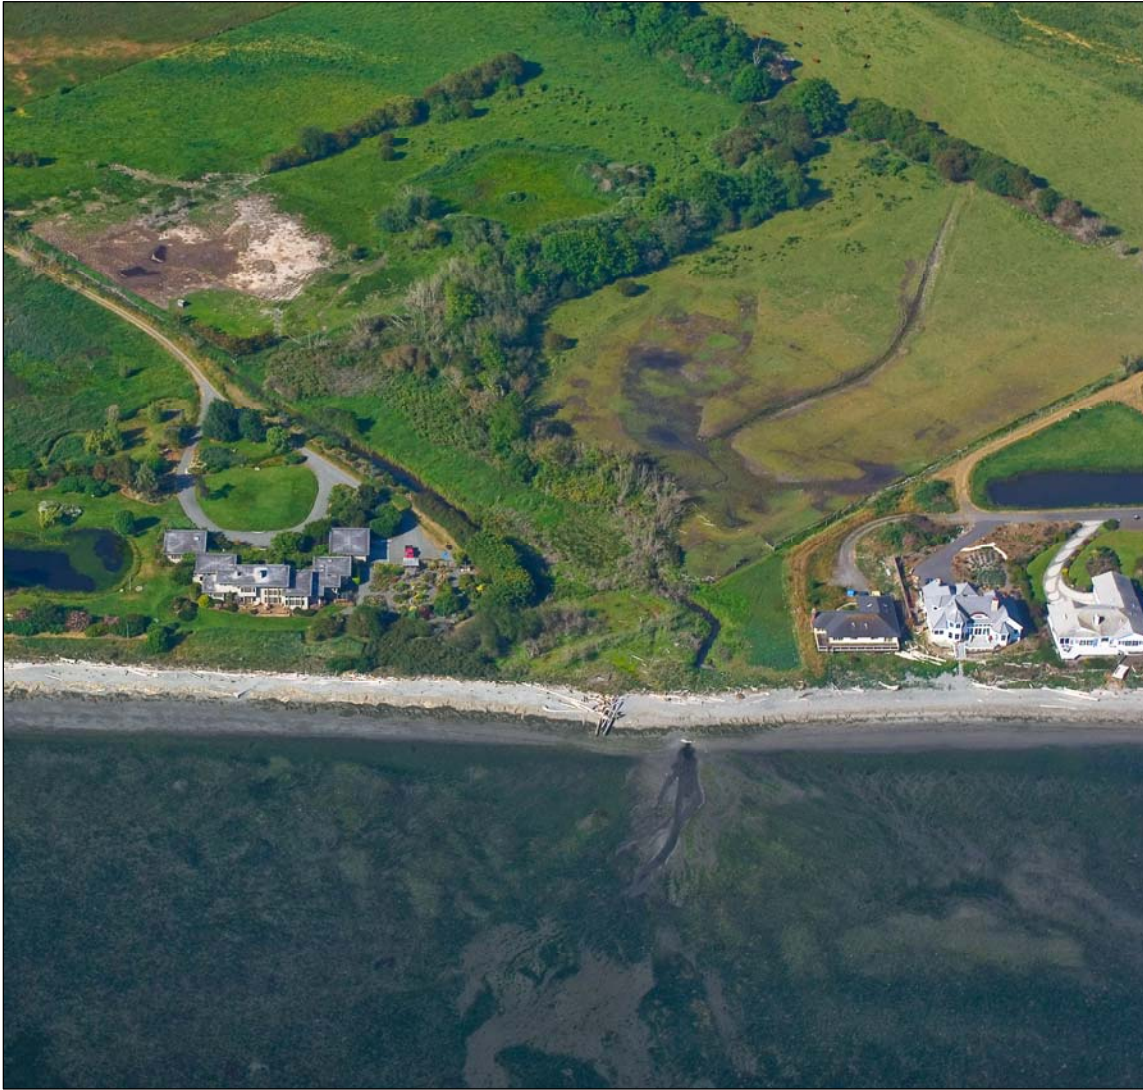
Figure 30 - Cassalery Creek mouth and estuarine area (2006 DOE photo)

Grazing impacts from cattle access to the lower marsh area of the McInnes farm are clearly evident. Cattle on the McInnes farm currently have direct access to the wetland area near the creek mouth, including drainage ditches that flow directly into Cassalery Creek. Although the forage production in this area is marginal, it does produce needed forage during late summer when the upland areas of the farm dry

out.² Forage production is marginal at best, and the lowest and wettest areas that are most prone to salt water intrusion during the winter have large areas of bare ground.
